MARINE INVESTIGATION REPORT
M01C0059

STRIKING

OF TANK BARGE *PML 2501*
BY CHEMICAL TANKER *CORAL TRADER*
ALGOMA STEEL CORPORATION WHARF
SAULT STE. MARIE, ONTARIO
22 AUGUST 2001

Report Number M01C0059

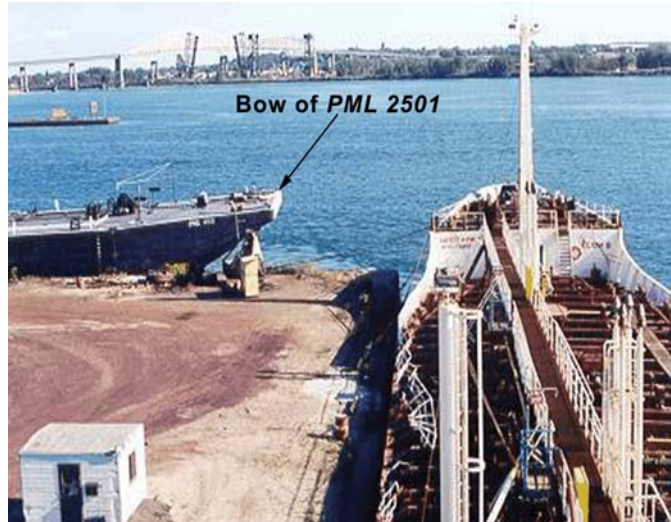
Photo 1. Forward view from *Coral Trader*'s bridge

The *PML 2501* is a square-ended, non-propelled petroleum tank barge of steel construction. It was moored in a westerly direction along the southern end of the Algoma Steel Corporation wharf (see Photo 1).

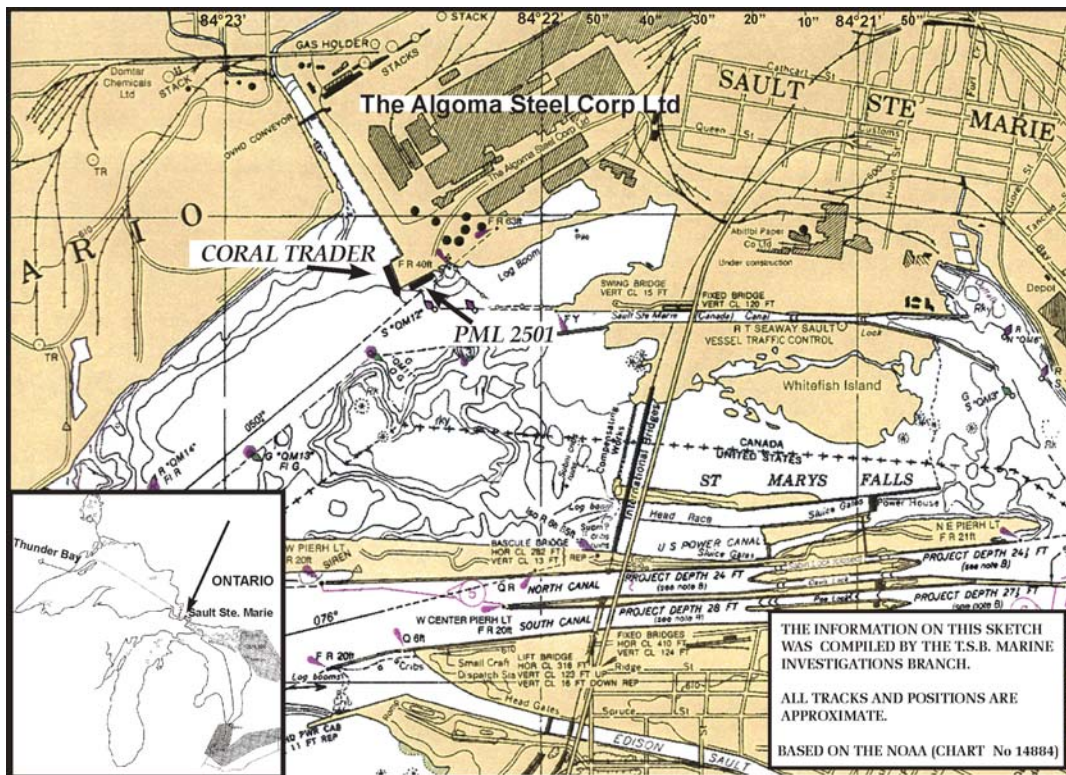
Figure 1. Area of occurrence showing initial location of *Coral Trader* and *PML 2501*

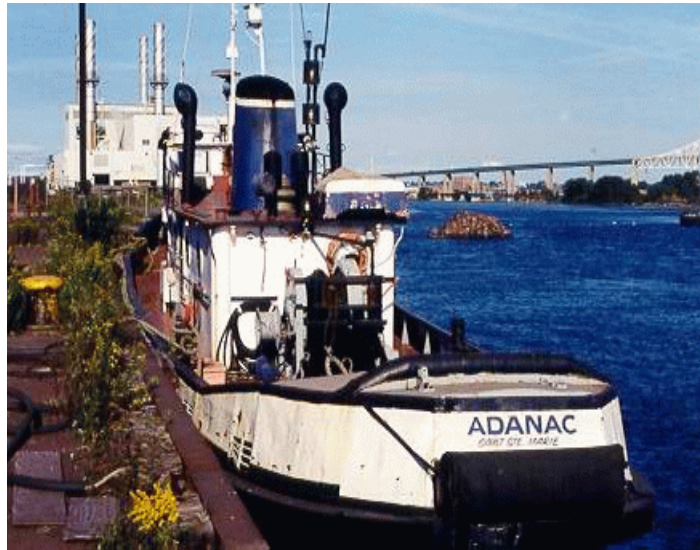
Photo 2. Tug *Adanac* (1000 BHP)

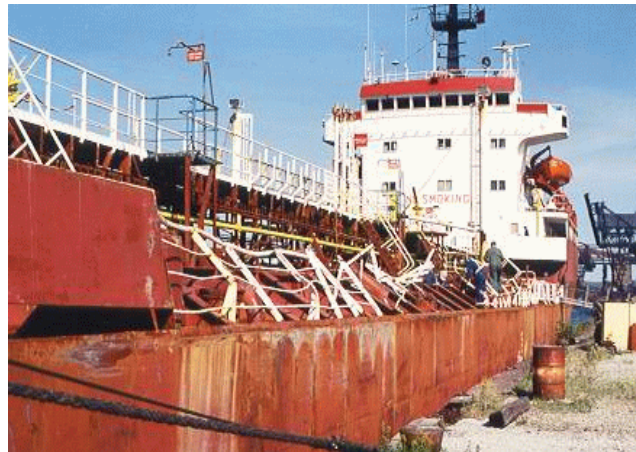
At approximately 2340, the *Coral Trader's* port side made contact with the port corner of the barge's bow. In continuing its astern manoeuvre while sideswiping the corner of the static barge, the *Coral Trader* suffered damage to its railings, manifold fittings and vents along the port side of the open deck (see Photo 3).

Photo 3. Port-side damage to *Coral Trader*
